Following report of an incident involving the failure of an air pressurised road tanker

REFERENCE: PEC 15
ISSUE: 01.1
DATE: 08/04/2021

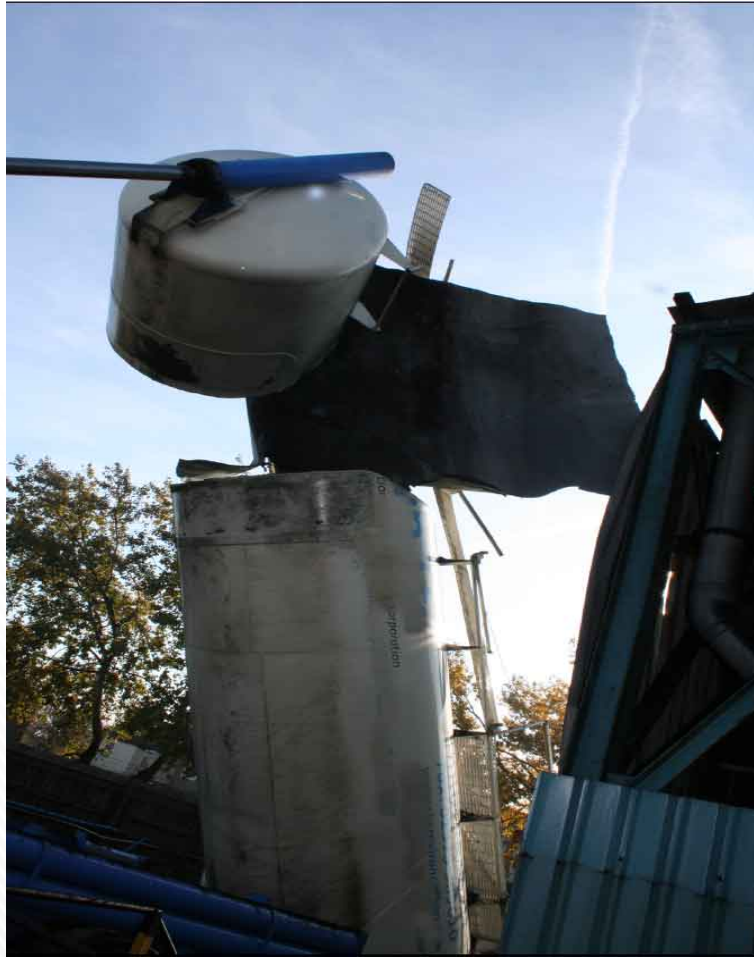
Discharge of the contents takes place through a nozzle connection in the rear of the tank using air pressure as a means of propulsion. As can be seen from the photograph at the time of failure the tank is tipped up vertically so that all of the contents can be discharged.

The carbon product is highly erosive and the jet of carbon entering the tank when the filling pipe was used caused smooth wastage to a localised area at the bottom of the tank. The smooth wastage could not be detected by visual examination of the tank although it would have been possible to detect it by ultrasonic thickness checks. Spot ultrasonic thickness measurements were routinely carried out local to the unloading nozzle during periodic examinations which is a well known problem area for erosion. There was a lack of awareness that the tanker could be filled through the nozzle connection in the top of the tank and the erosive effect this had on the tank shell.

An investigation of the incident revealed that the initial failure was longitudinal at around bottom dead centre position below the loading nozzle. The failure propagated in longitudinal direction to the adjacent points where the shell was reinforced by doubling plates [chassis resting points]. The failure then continued in a circumferential direction along both reinforced areas to a point where the shell was almost separated in two. Checks on similar tankers in the fleet revealed that they also had erosion in the same area.

Failed tanker in the upright tipping discharge position

It is essential that vessels [including road tankers] that may be subject to erosion especially during filling and/or discharge operations are subject to ultrasonic thickness checks in susceptible areas. It is therefore important to understand how the equipment operates in order to identify potential problem areas.

Where there is potential for erosion then routine ultrasonic thickness checks should be specified on reports and included on the written scheme of examination for the item.
