SAFETY ASSESSMENT  
FEDERATION

Following report of an incident  
involving the failure of an  
autoclave door

REFERENCE: PEC 16  
ISSUE: 01.1  
DATE: 08/04/2021

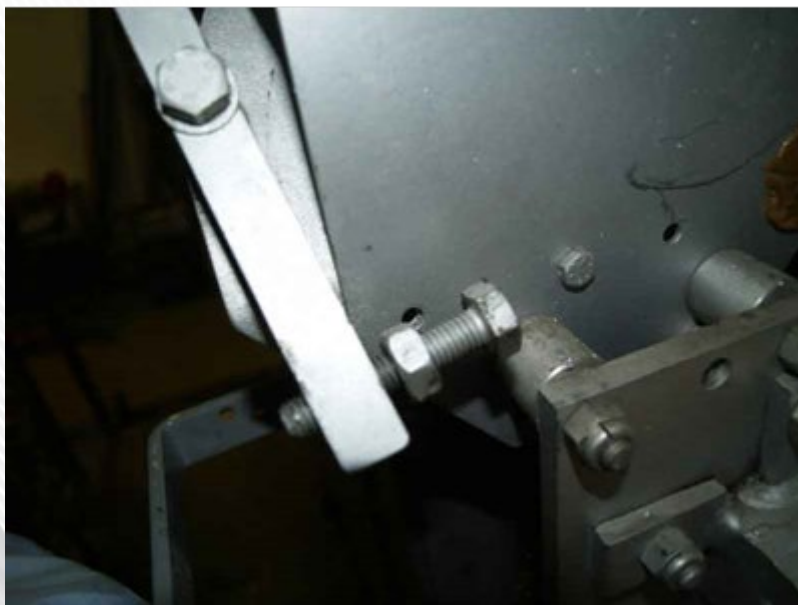
**Rocker arm with adjusting bolt - Note: bolt is not locked**

At the time of the incident, evidence would indicate that the door stopped approximately 10 mm short of full closure and the door clamps closed on to the door in this position [see marks on door clamping area]. With the door in this position the air switch interlock should have prevented steam being admitted to the steriliser chamber, however as can be seen in the photograph the adjusting bolt on the rocker was not locked and it is assumed that it was not in correct adjustment and steam was admitted to the chamber.

Engineer Surveyors should draw users' attention to the fact that interlocks should always be correctly adjusted and locked and that interlocks should be checked for correct operation at regular intervals.

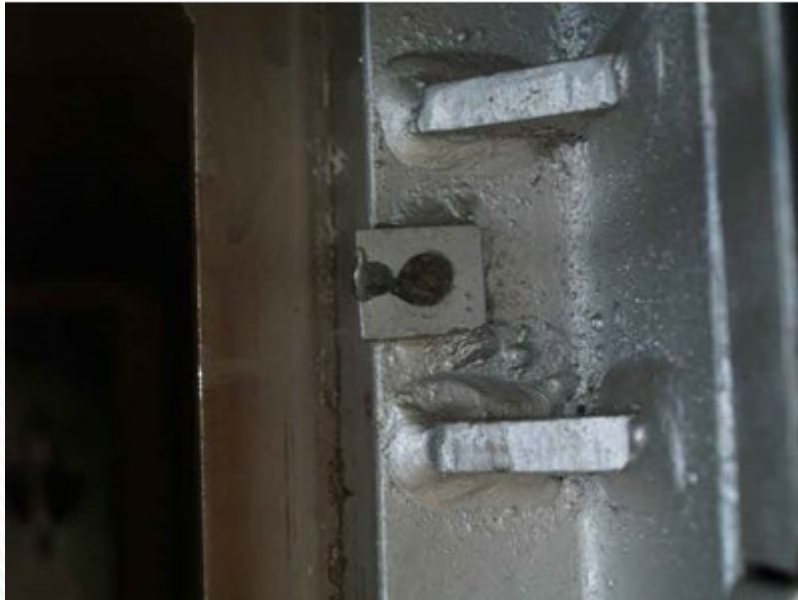
**Note:** normal closed position marking, not fully closed position marking and marking due to "slipping" off clamp.
