Guidance In-Service Inspection Guidance

Remote Visual Inspection

REFERENCE: RVI 001 ISSUE: 02 DATE: 17/11/2021

Remote Visual Inspection (RVI) of a Horizontal Multi-tubular Steam Boiler

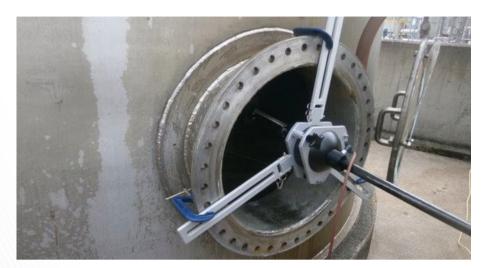
The camera was fixed to the lower manway for the purpose of this test. (See Figure 6). In order to complete a full examination of the tank it would have been necessary to move the camera to the upper manway. From the lower position it was possible to examine (eventually) the upper nozzle attachments which were approximately 3.5 m above the camera entry point and also the attachments for the fill line (2.5 m above). The camera operators were untrained site staff and followed the camera supplier's basic instructions before use. Skill levels increased throughout the trial and the images produced were of very good quality.

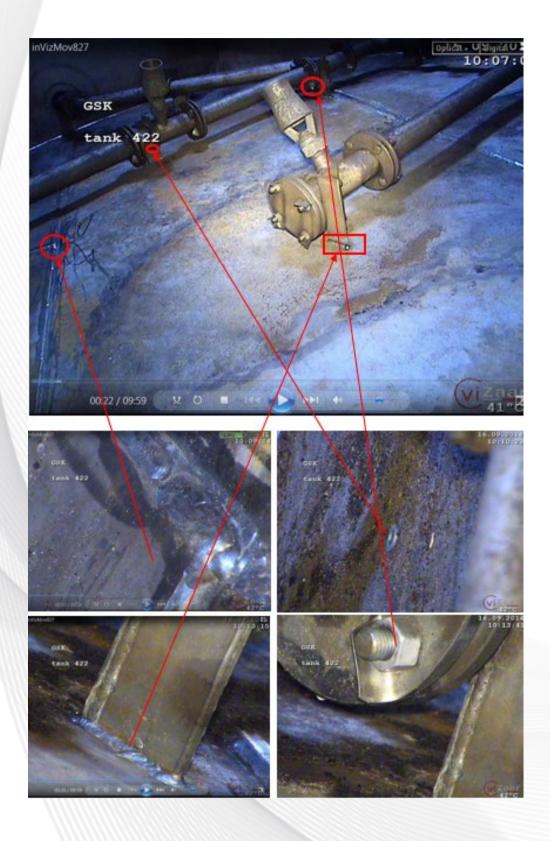
- 1. In order to complete a full visual examination of the tank it is clearly going to be necessary to adjust the camera position a few times.
- 2. The video footage produced was of fair quality but could have been improved by covering the upper manway opening in order to achieve better contrast.
- 3. The tank would still need to be cleaned, probably more effectively than for man entry.
- 4. Examination of the tank floor remains an issue, particularly in the case of carbon steel tanks where the probability of corrosion from the underside needs to be addressed.
- 5. Checking the floor for settlement or lifting. This could possibly be assessed by flooding the lower parts of the tank with water to highlight high/low points.

- **1.** Blank off the stray light coming from the upper manway.
- 2. Use the upper manway as a second camera mounting point.
- **3.** Operator training in the use and functions of the camera as only basic functions were used during this trial.

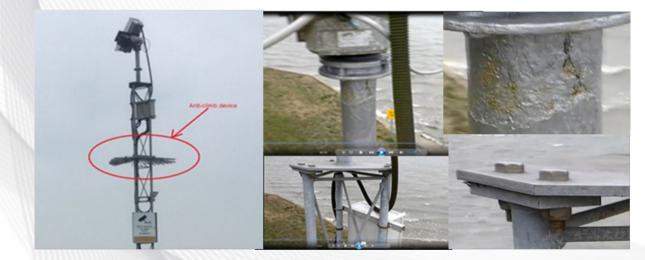
The mast requires inspection but cannot be climbed due to the anti-climbing device around it. Due to the location a MEWP is not feasible. Use of Remote Visual Inspection techniques allowed close up inspection of the structure and fixings. The inspection was recorded throughout in HD and still images were taken.
