IN-SERVICE INSPECTION PROCEDURES

Number: **PEC 18 b**

Reference: **Trial: Remote visual inspection (RVI) of static storage tank**

Tank Details: Stainless Steel Storage Tank

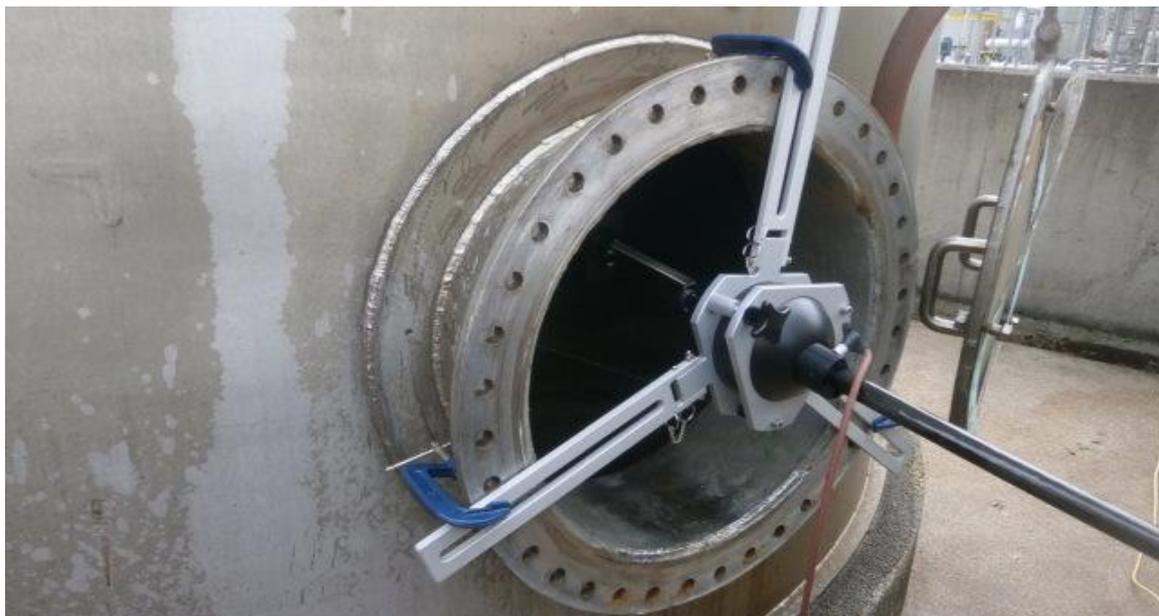
Figure 6 – Tank entry location

The camera was fixed to the lower manway for the purpose of this test. (See Figure 6). In order to complete a full examination of the tank it would have been necessary to move the camera to the upper manway. From the lower position it was possible to examine (eventually) the upper nozzle attachments which were approximately 3.5 m above the camera entry point and also the attachments for the fill line (2.5 m above). The camera operators were untrained site staff and followed the camera supplier's basic instructions before use. Skill levels increased throughout the trial and the images produced were of very good quality.

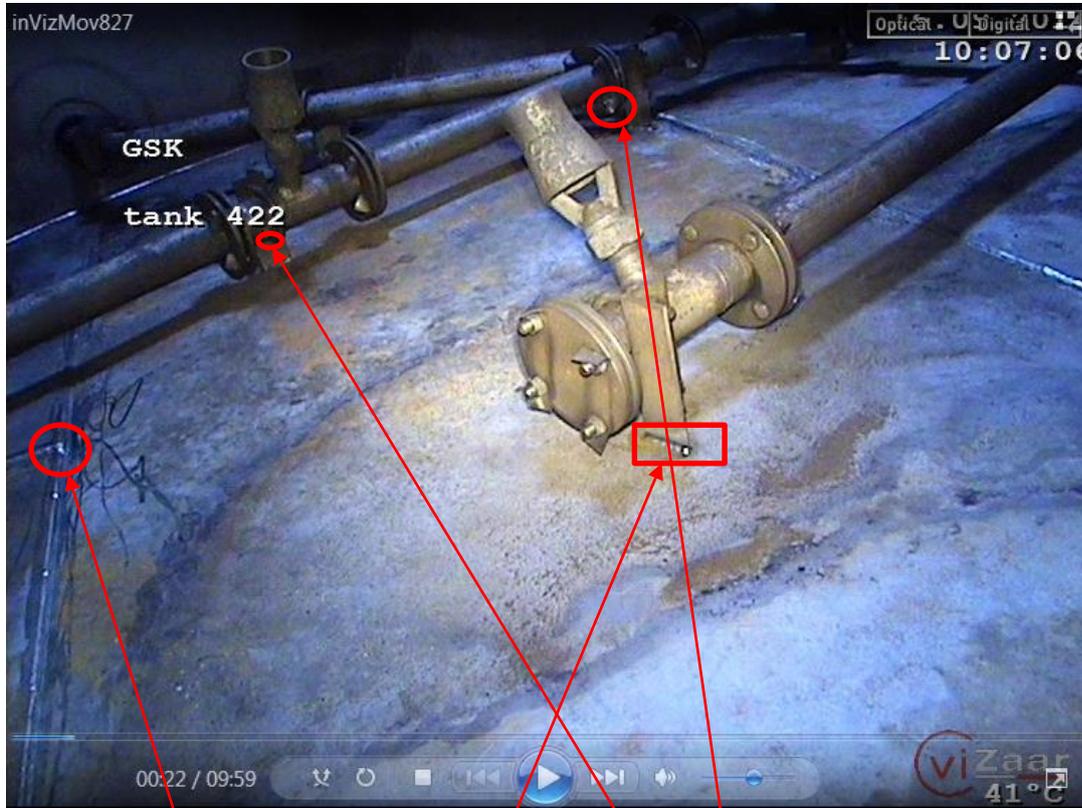
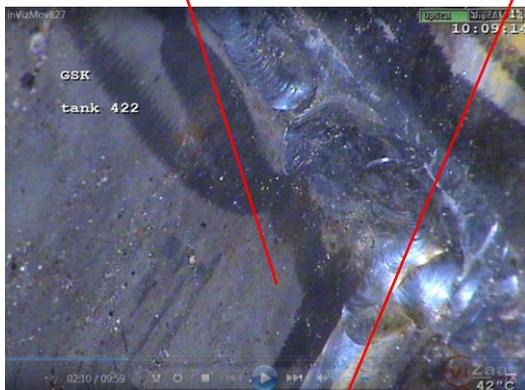
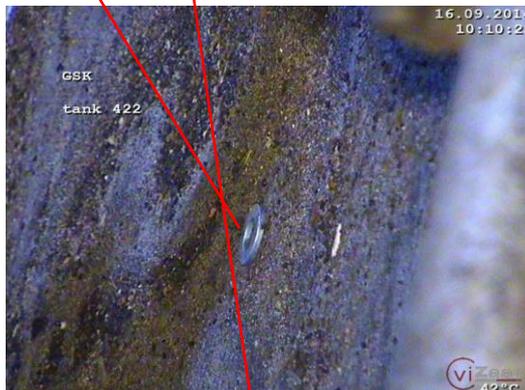
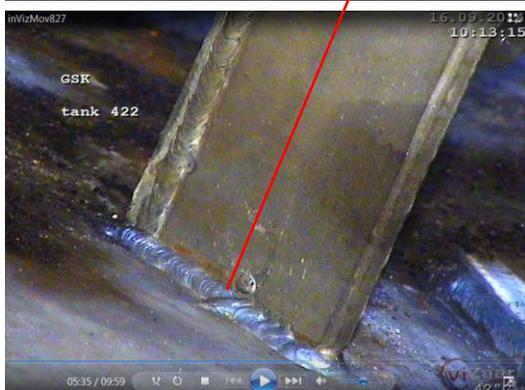
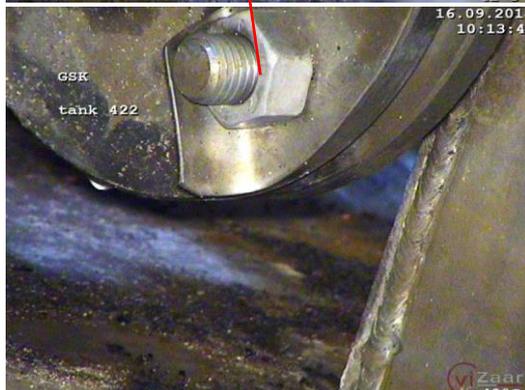
General View of Floor

Images of Tank base from lower manway.
