GUIDANCE

Number: **PEC 20**

Reference: **Guidance – Inspection of Wellman Robey Ygnette/Sygnette Boilers (2007 – 2016)**

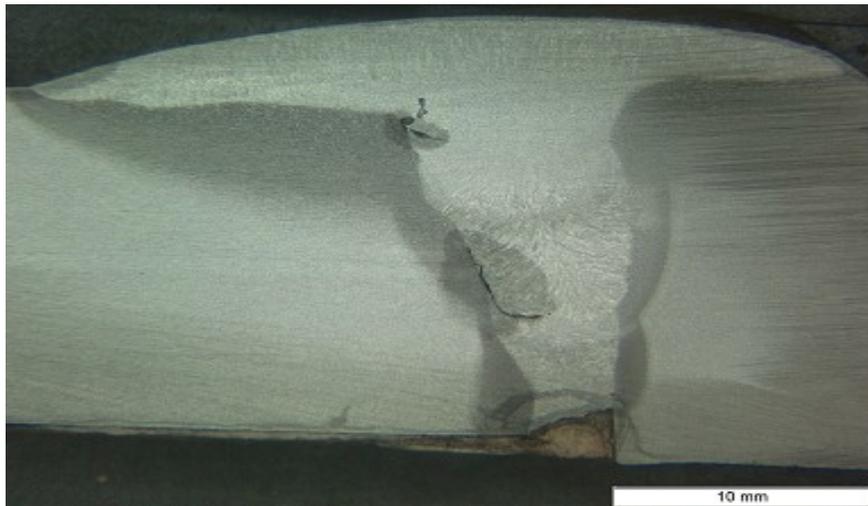
Figure 1 – Furnace Front

Defects: lack of sidewall and inter run fusion and lack of root penetration

The investigation did not reveal any evidence of any of these defects initiating cracks after five years in service, for the particular boiler under investigation. However this does not provide any assurance that the defects will not start to develop cracks in the future. Certainly the presence of the defects will undoubtedly significantly increase the probability of cracking in the future.

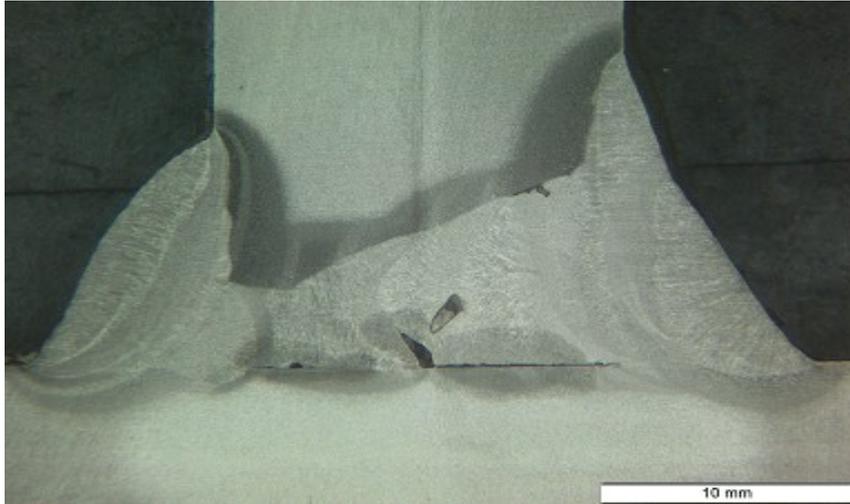
Figure 2 – Shell to tubesheet (front)

Defects: unfused land in two areas, lack of side wall fusion and inclusions
