GUIDANCE

IN-SERVICE INSPECTION PROCEDURES

Number: **PEC 15**

Reference: **Guidance – Following report of an incident involving the failure of an air pressurised road tanker**

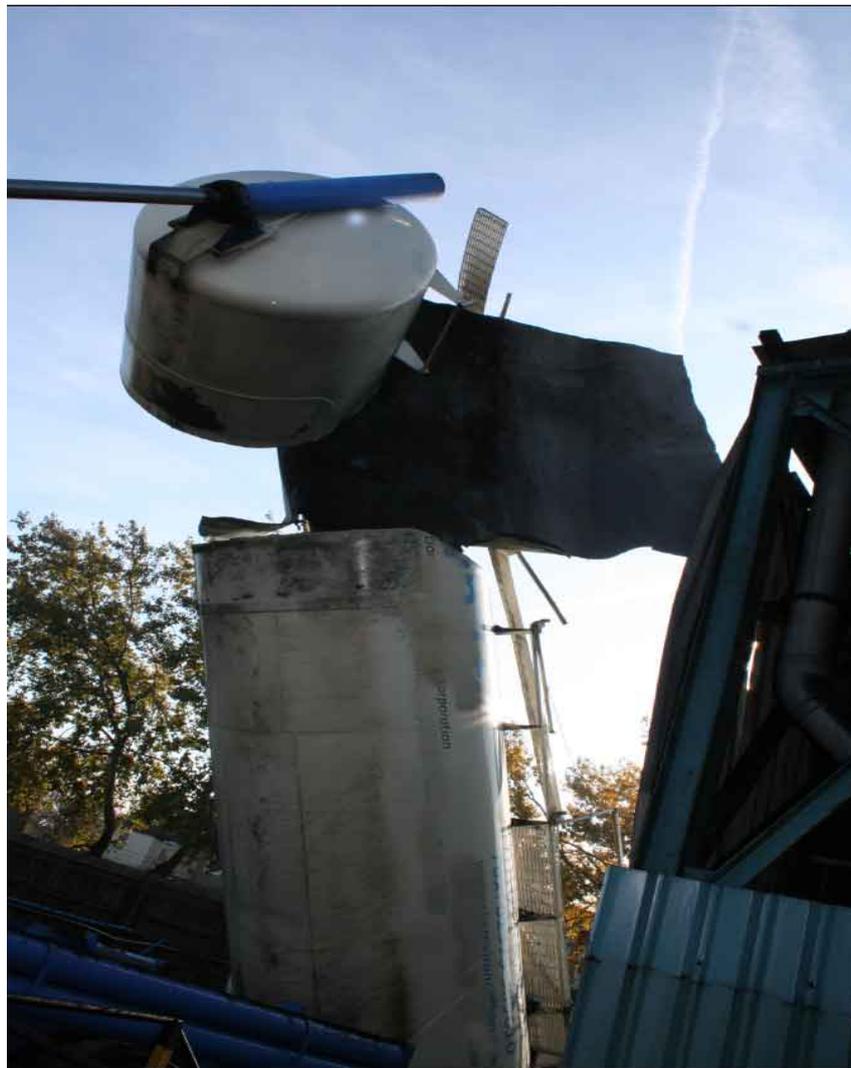
Discharge of the contents takes place through a nozzle connection in the rear of the tank using air pressure as a means of propulsion. As can be seen from the photograph at the time of failure the tank is tipped up vertically so that all of the contents can be discharged.

The carbon product is highly erosive and the jet of carbon entering the tank when the filling pipe was used caused smooth wastage to a localised area at the bottom of the tank. The smooth wastage could not be detected by visual examination of the tank although it would have been possible to detect it by ultrasonic thickness checks. Spot ultrasonic thickness measurements were routinely carried out local to the unloading nozzle during periodic examinations which is a well known problem area for erosion. There was a lack of awareness that the tanker could be filled through the nozzle connection in the top of the tank and the erosive effect this had on the tank shell.

An investigation of the incident revealed that the initial failure was longitudinal at around bottom dead centre position below the loading nozzle. The failure propagated in longitudinal direction to the adjacent points where the shell was reinforced by doubling plates [chassis resting points]. The failure then continued in a circumferential direction along both reinforced areas to a point where the shell was almost separated in two. Checks on similar tankers in the fleet revealed that they also had erosion in the same area.

Failed tanker in the upright tipping discharge position

It is essential that vessels [including road tankers] that may be subject to erosion especially during filling and/or discharge operations are subject to ultrasonic thickness checks in susceptible areas. It is therefore important to understand how the equipment operates in order to identify potential problem areas.

Where there is potential for erosion then routine ultrasonic thickness checks should be specified on reports and included on the written scheme of examination for the item.
