IN-SERVICE INSPECTION PROCEDURES

Number: **PEC 16**

Reference: **Guidance – Following report of an incident involving the failure of an autoclave door**

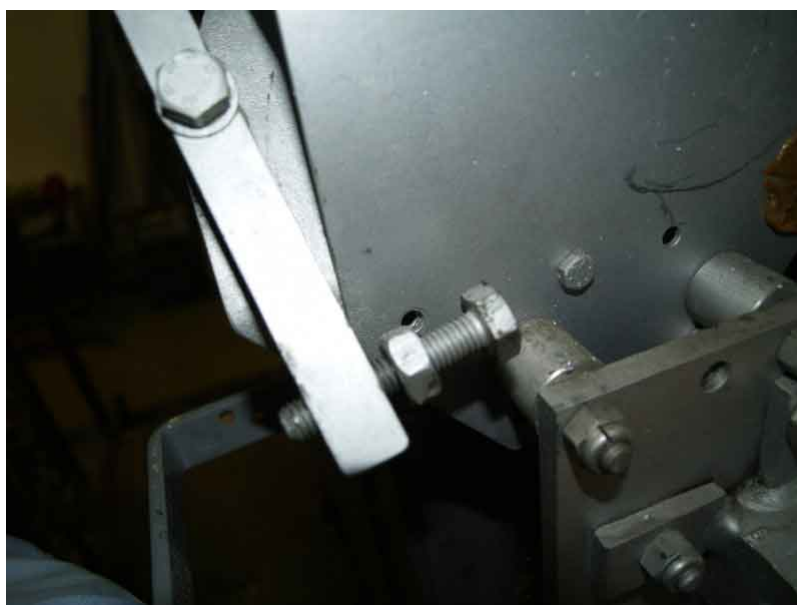
Rocker arm with adjusting bolt - Note: bolt is not locked

Initial investigation indicated that the electrical interlocks were probably set to operate before the door was fully closed.

Engineer Surveyors should draw users' attention to the fact that interlocks should always be correctly adjusted and locked and that interlocks should be checked for correct operation at regular intervals.

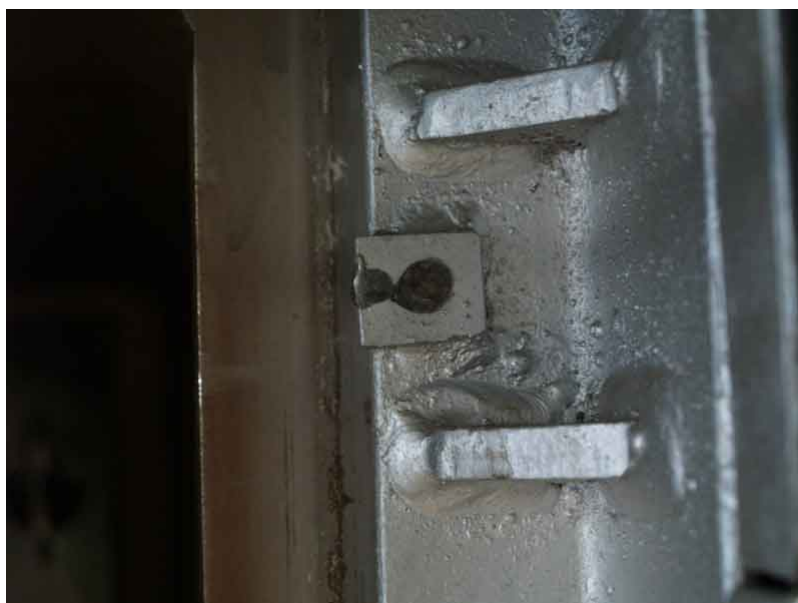
Door clamping area

At the time of the incident, evidence would indicate that the door stopped approximately 10 mm short of full closure and the door clamps closed on to the door in this position [see marks on door clamping area]. With the door in this position the air switch interlock should have prevented steam being admitted to the steriliser chamber, however as can be seen in the photograph the adjusting bolt on the rocker was not locked and it is assumed that it was not in correct adjustment and steam was admitted to the chamber.

Note: normal closed position marking, not fully closed position marking and marking due to "slipping" off clamp.
