SAFETY ASSESSMENT
FEDERATION

Guidance on the use of drone technology and data to support thorough examination / inspection of various types of plant and equipment.

REFERENCE: D 001

ISSUE: 02

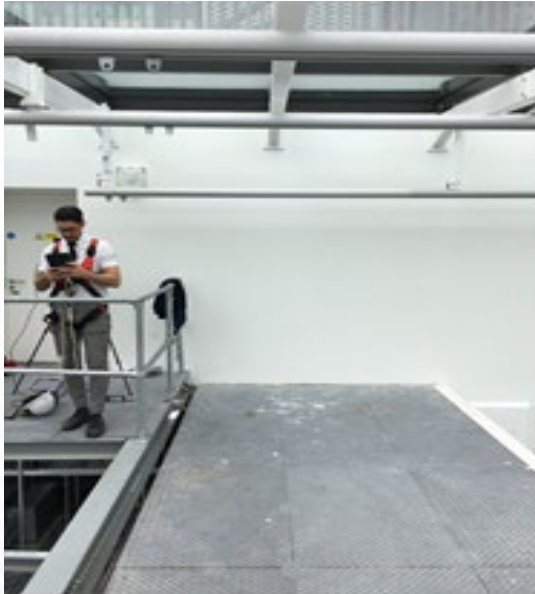
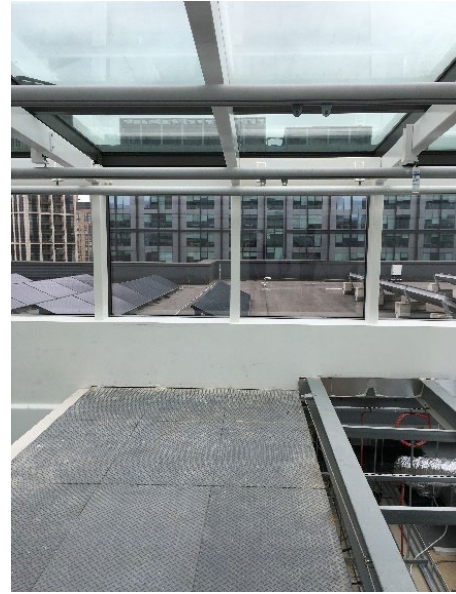
- The rigging platform area would be used to make a sample assessment for the fixings which were accessible for close tactile scrutiny.

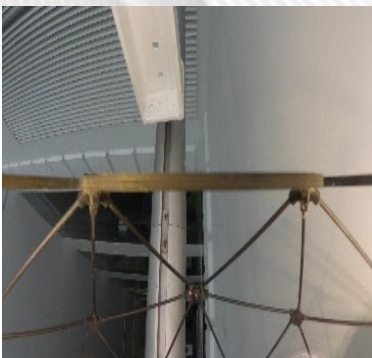
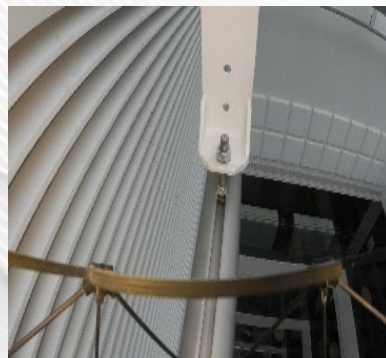
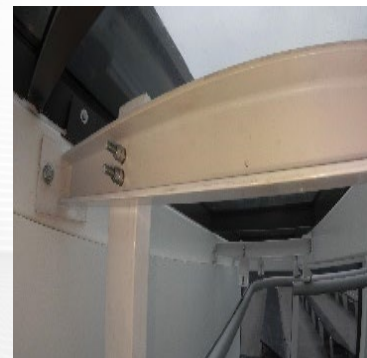
The access difficulties at the upper atrium level which could potentially have resulted in entrapment of the drone were discussed. A flight path was chosen which both ensured the detail necessary was observed and minimised the potential for drone entrapment.

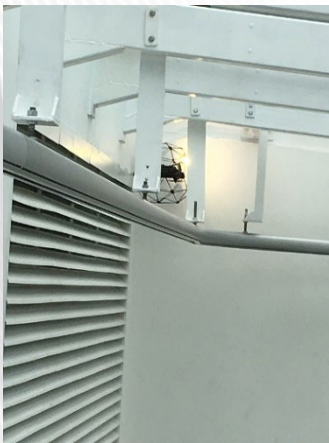
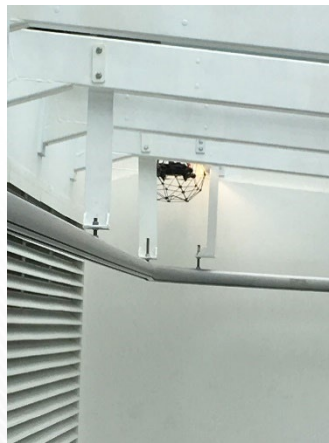
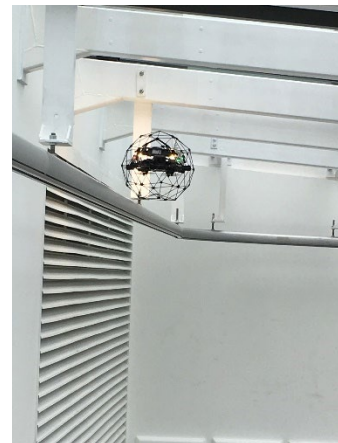
The drone was used to provide visual evidence of the critical elements of the rail assemblies:

- Upper hanger fastening bolts/nuts.
- Lower hanger rail stud/nut and hanging 'T' blocks.
- Rail section jointing plate and fasteners.
- Critical welds.

The drone could be readily manoeuvred into locations which enabled the critical elements to be displayed and filmed. Image quality was very good on the monitor. Points of Interest (POI's) could be individually recorded and the full flight filmed. These records could then be appended to the given item.

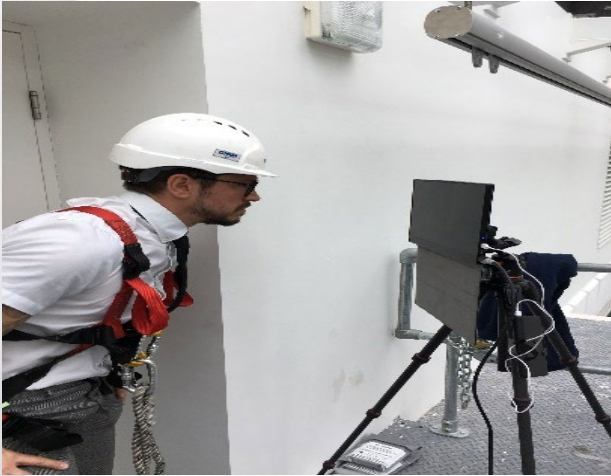
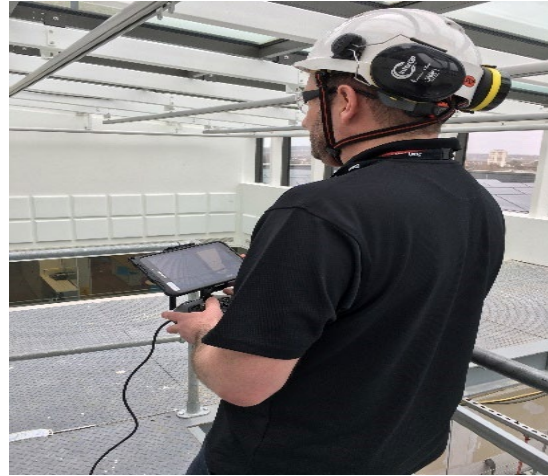
The drone could be readily manoeuvred into locations which enabled inaccessible critical elements to be displayed and filmed.

Points of Interest (POI's) could be individually recorded and the full flight filmed.

The technology could supplement those inspections where access by an Engineer Surveyor is both unsafe and/or physically inaccessible. In certain circumstances this could enhance the equipment scrutiny data, due to manoeuvrability into areas which would not normally be accessible.

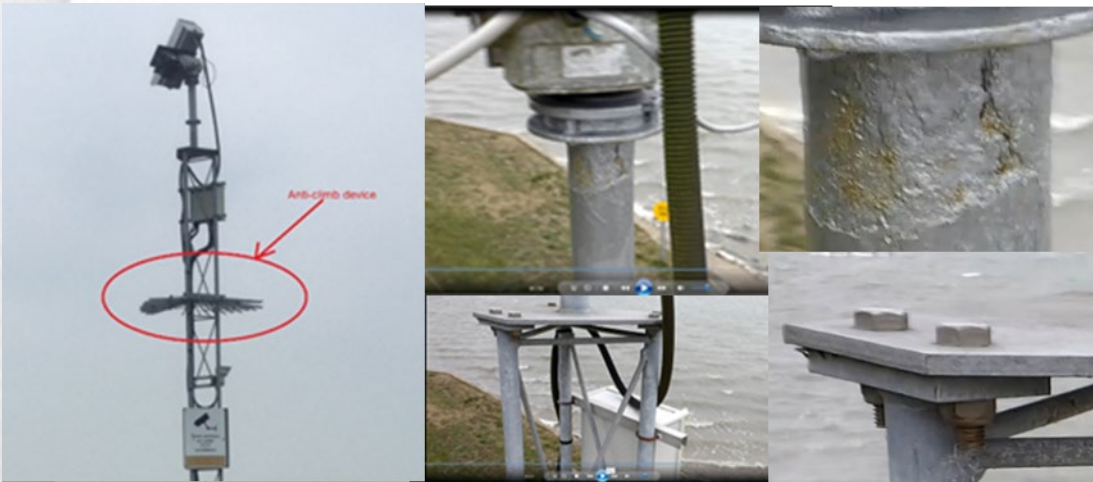
CCTV Mast with anti-climbing feature.

The mast requires inspection but cannot be climbed due to the anti-climbing device around it. Due to the location a MEWP is not feasible. Use of Remote Visual Inspection techniques allowed close up inspection of the structure and fixings. The inspection was recorded throughout in HD and still images were taken.

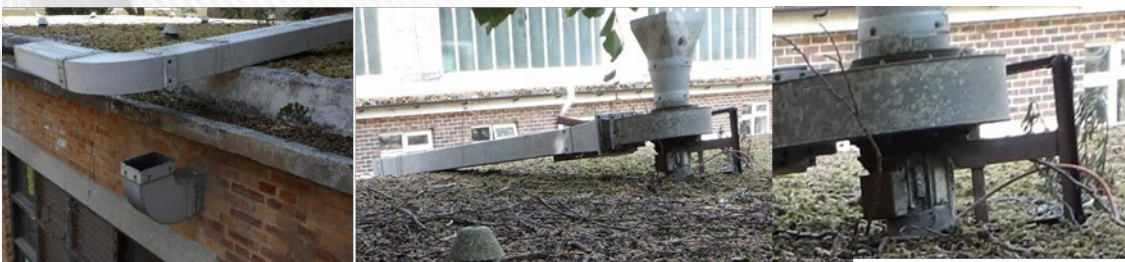
Inaccessible roof with an LEV fan on it. System performance was poor and from beneath it was apparent there was an issue with the ducting. Use of Remote Visual Inspection techniques revealed that the fan had fallen from its mounting.

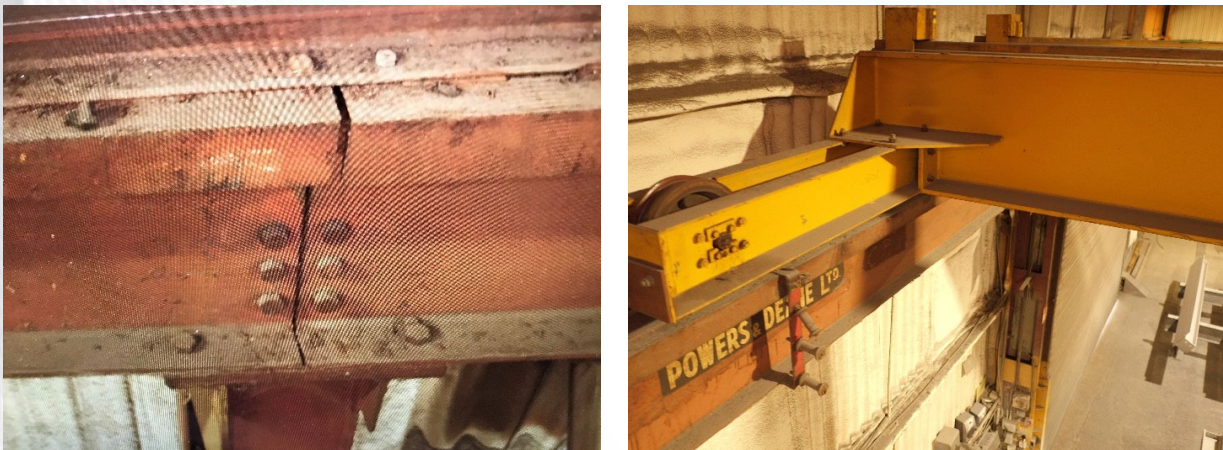
- Dust and debris were immediately disturbed by downwash of drone.
- Drone lighting pods were essential to image quality.
- Larger drone (DJI Inspire) was too big for internal flight – too much disturbed air especially when in close proximity to ceiling and wall – whilst testing field of view of upper inspection surfaces, the lower pressure above propellers caused un-commanded altitude increase and drone impact with ceiling. Control was recovered and drone landed safely but with damage. Smaller, caged drone to be used at next internal/close proximity test.

- Video footage unstable and not deemed of much benefit if only for position reference.
- Images of high quality with zoom capability very useful.
- Torque reference for attached hardware required e.g. witness marks.

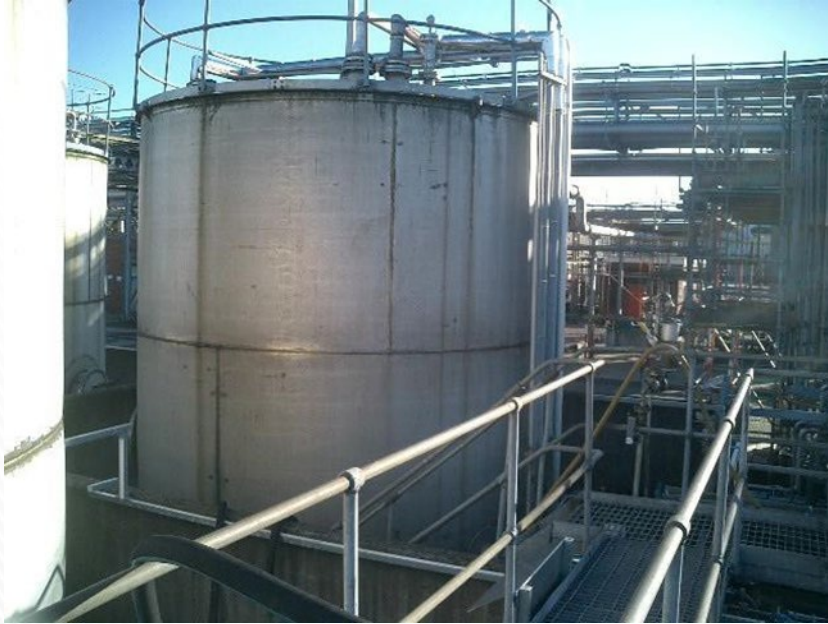
Remote visual inspection (RVI) of static storage tank.

The camera was fixed to the lower manway for the purpose of this test. (See Figure 1). In order to complete a full examination of the tank it would have been necessary to move the camera to the upper manway. From the lower position it was possible to examine (eventually) the upper nozzle attachments which were approximately 3.5 m above the camera entry point and also the attachments for the fill line (2.5 m above). The camera operators were untrained site staff and followed the camera supplier's basic instructions before use. Skill levels increased throughout the trial and the images produced were of very good quality.

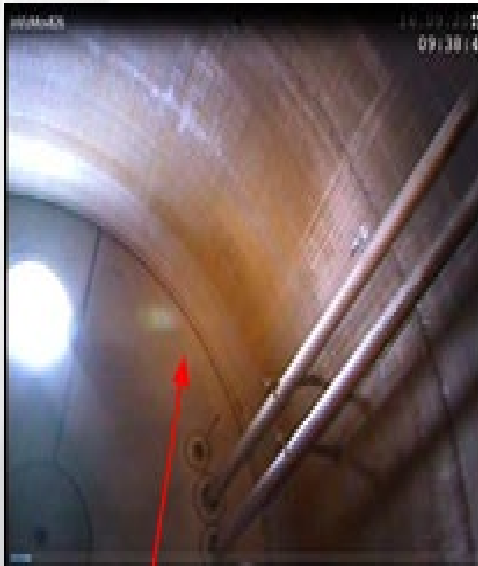
Top View 1

Images of Upper Surfaces and Tank Walls.
Note the camera remains fixed to the lower manway.
