GUIDANCE

IN-SERVICE INSPECTION PROCEDURES

Number: **PEC08**

Prepared by: **Pressure Equipment Committee (TC1)**

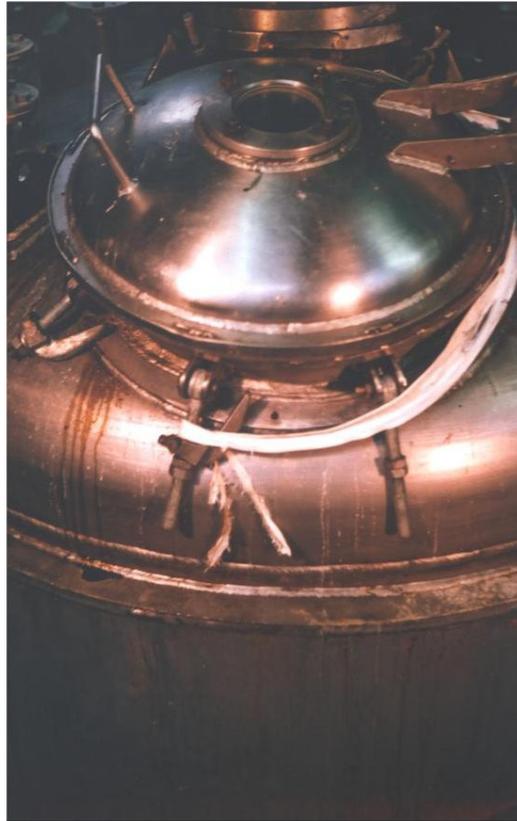
In particular, HSE’s investigation found that the company had failed to put in place adequate operating procedures to ensure the system was used correctly. For example, clamps were regularly over-tightened, occasionally causing them to break and the system was allowed to operate with less than its full complement of eight clamps.

At the time of the accident, one of the clamps was missing and others showed excessive wear and tear, or inadequate repair. Furthermore, it had become common practice for leaks to be nipped up with the system under pressure because the operating procedures failed to state that the system should be depressurised first.

Figure 1: Photograph showing door and retaining bolts

“The investigation also revealed that although the company had arranged for an independent competent person to examine the pressure system periodically, this was insufficient due to the frequent operation of the clamps, and the high level of wear and tear they showed. Instead, the firm should have introduced a more frequent system of inspection and maintenance.”

In light of the incident described above the HSE have warned of the need for effective operation, inspection and maintenance regimes to ensure the safe use of pressure equipment.

Comments should be made on the report of examination reminding the User/Owner of these responsibilities.

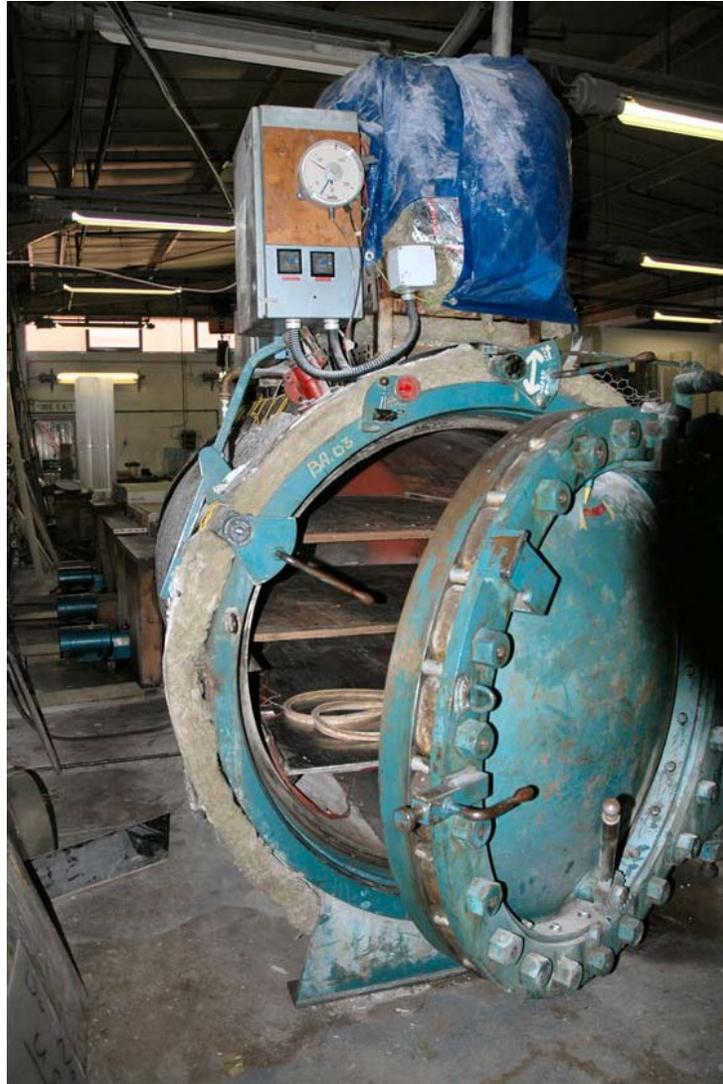
2 workers sustained serious injuries when the autoclave door catch mechanism failed causing the door of an autoclave open suddenly and striking the 2 workers.

One of the door locking handles prevents rotation of the door before the vessel is depressurised. This is achieved through a series of linkages from the handle to an exhaust valve which vents the vessel contents.

A colleague went to his assistance and between them were able to move the door. Unfortunately there was a sudden movement of the door which resulted in the two men being thrown through the air and sustaining serious injury due to impact against a wall.

Figure 2: View of Autoclave Door etc

PSG04 clearly identifies the types of protective and safety control devices which should be fitted to this type of vessel along with the need to include them within the Written Scheme of Examination and to ensure that those identified devices are subjected to an appropriately detailed examination.

If the Written Scheme of Examination does not include details of any such devices then it shall be deemed inadequate and revised accordingly.

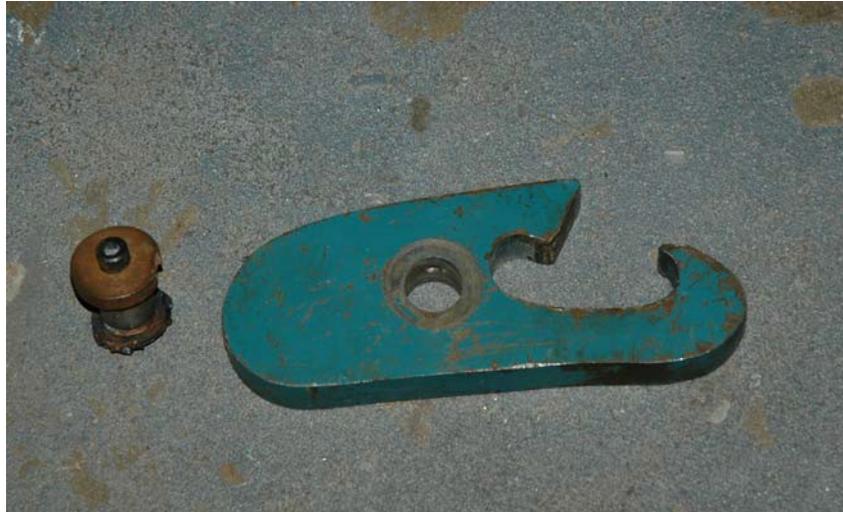
- 1) It would appear that wear in the linkages of the pressure venting device prevented the device from operating correctly, therefore when the operators went through the door opening sequence there was a pressure build up behind the door. This would also explain why the operators felt that the door was “difficult to open”.
- 2) When the door did open with pressure still in the vessel a safety latch should have prevented the door opening more than a small distance thereby allowing any residual internal pressure to be released without injury to persons. The hinge pin of this safety latch appears to have failed when the door opened causing the door to open fully causing the injury to the two operators. It was also noted that the latch pin had been previously repaired and that the failure had originated at the repair.

Figure 3: Retaining Latch and Pin (Broken)

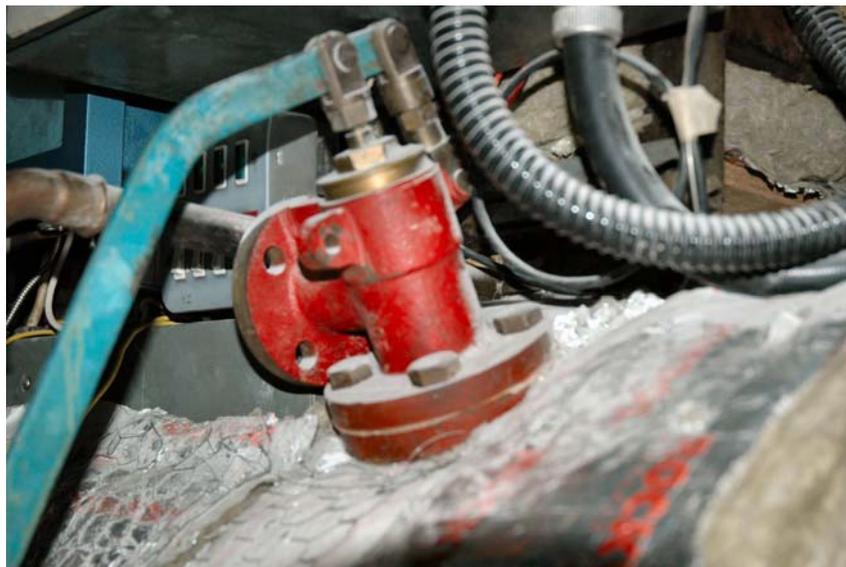
Exhaust Valve (showing part linkage)
