SAFETY ASSESSMENT  
FEDERATION

# Guidance

For vessels with fusion welded  
cladding

REFERENCE: PEC 17  
ISSUE: 02  
DATE: 01/06/2011

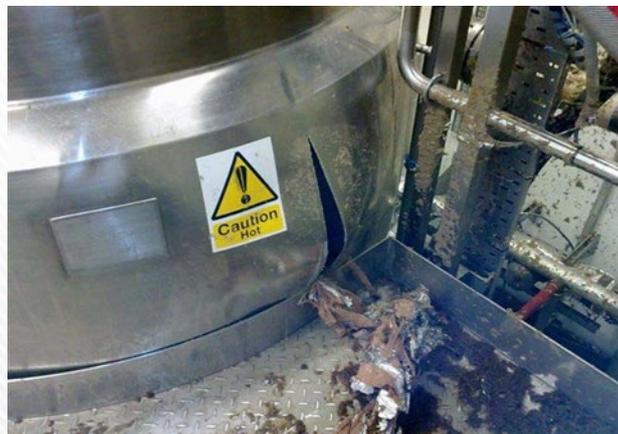
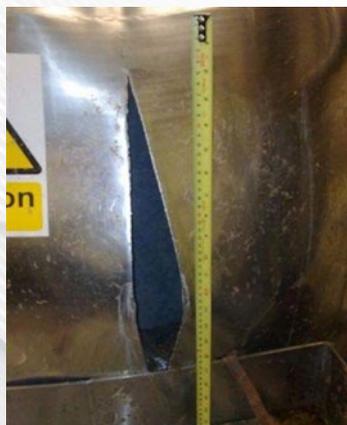
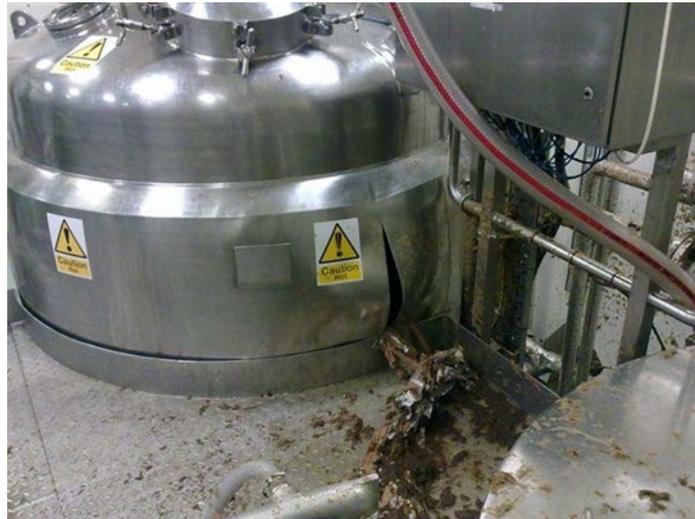
A typical incident is illustrated below. This resulted in the release of steam from a jacketed vessel operating at a pressure of approximately 2 bar. Injury to production personnel was narrowly avoided. The vessel was manufactured from stainless steel and constructed in accordance with PD5500. It also complied with the requirements of the Pressure Equipment Directive.

The nozzle feeding steam to the jacket failed within the insulation space, causing it to become pressurised. The casing had no provision for venting and the pressure rose to the extent that it could no longer withstand the stress and ruptured along a longitudinal seam weld, releasing steam across the operator's platform.

This unit was supplied with steam at a maximum pressure of 3.0 bar so the casing failed at a pressure less than is:

Unless the casing is designed as a pressure vessel in its own right the vessel design codes do not generally include requirements for their design and the likelihood of pressurisation is not addressed unless the manufacturer specifically takes this into account. For equipment supplied under the Pressure Equipment Directive the manufacturer is required to carry out a hazard assessment and then take appropriate steps to eliminate any hazard, apply protective measures or provide warning information. The instructions for use should be checked to see if the hazard of pressurisation of the casing has been addressed. Where this is not included, or for existing plant, possible precautions could be:

- Fit a vent to the casing. (This is not usually permitted where a sealed casing is specified).
- Fit a pressure warning device within the casing.
- Design the casing with a weak seam which would fail in a safe manner if under minimal pressure.
- Fit a low pressure bursting disc into the casing.

If none of these precautions are practical the owner/user may consider it necessary to restrict access to the vessel whilst it is under pressure.
