Guidance In-Service Inspection Guidance

Remote Visual Inspection

REFERENCE: RVI 001 ISSUE: 02 DATE: 17/11/2021

Remote Visual Inspection (RVI) of a Horizontal Multi-tubular Steam Boiler

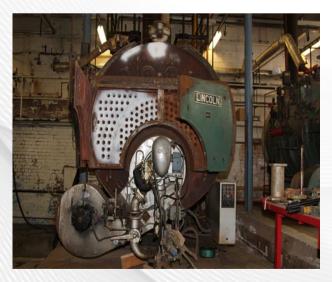
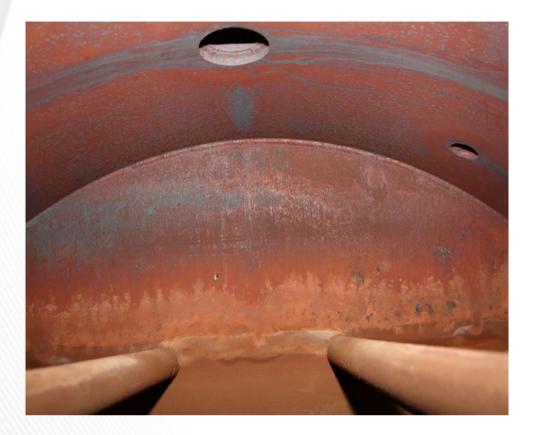
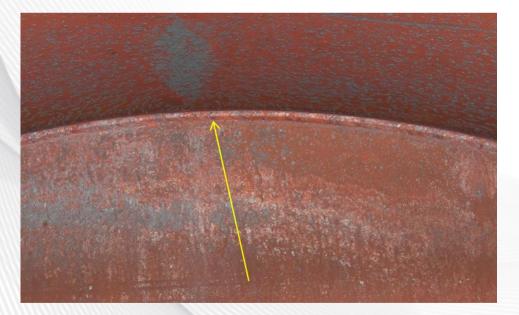
Both sets of equipment were capable of resolving the simulated defects placed in the boiler. Whether the operator would or could have positioned the camera to find the defects without being directed to them was not determined. The memory card used to record the results of the second examination was defective and the test was not repeated as it would have been for a genuine plant examination so there are no photographic and video records of this.
