# Pressure Guidelines

**Guidelines for the Competent Person.  
In-service examination of manhole and  
handhole spigot gaps in boilers and other  
pressure vessels.**

**PSG 14 — Issue 01.1 — Dated 07<sup>th</sup> January  
2019**

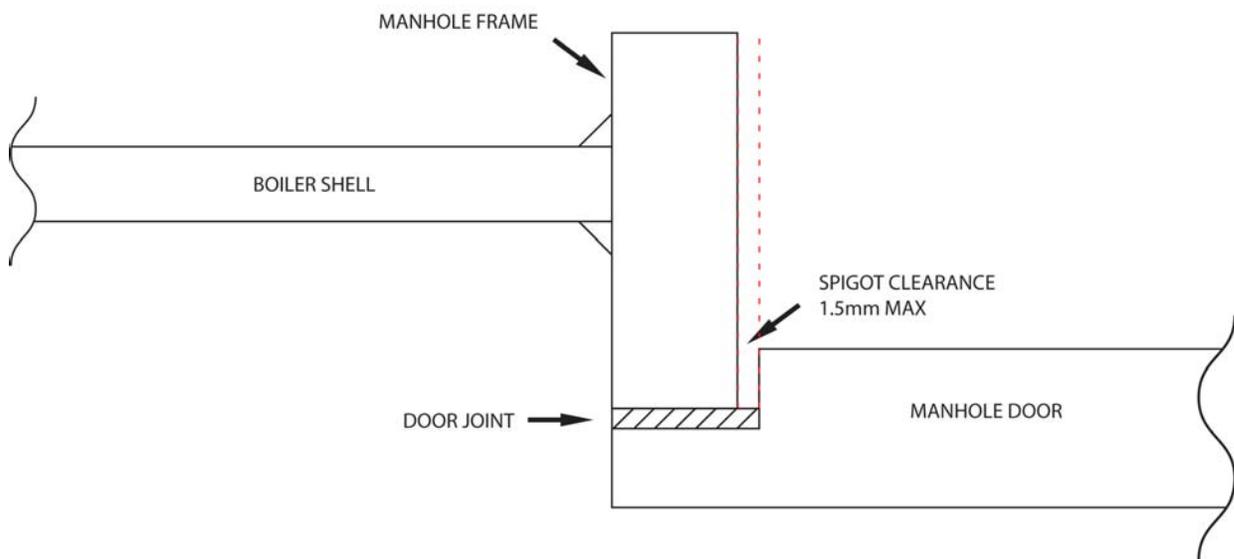
### Fabricated or McNeill type door

Spigot gaps can be readily measured with the door in position and with or without the door joint.

There are well established methods for the repair of fabricated or McNeill doors where the door spigot gap has increased. This method utilises weld overlay to the door, frame or plate edge dependant on where degradation has taken place and subsequent machining of the joint face.

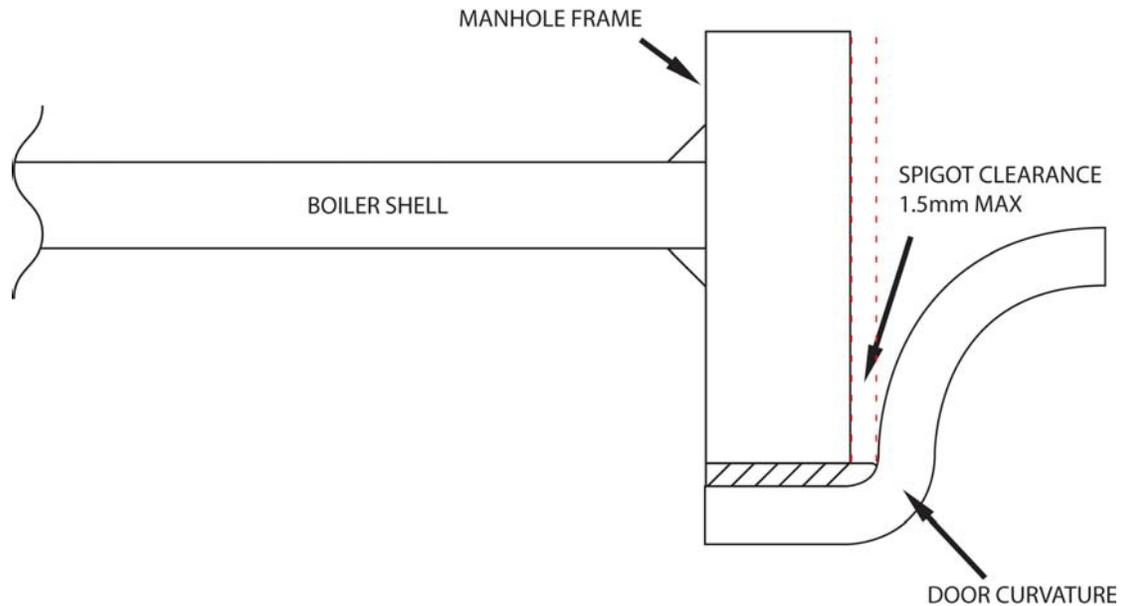
## Pressed steel type door

The curvature of the door and the radius adjacent to the joint seating area can interfere with the measurement depending on the thickness of the joint. Also the radius and the included angle can make the joint more susceptible to failure.

Generally welding should not be carried out on pressed doors as the heat applied may cause the door face to distort causing sealing issues.

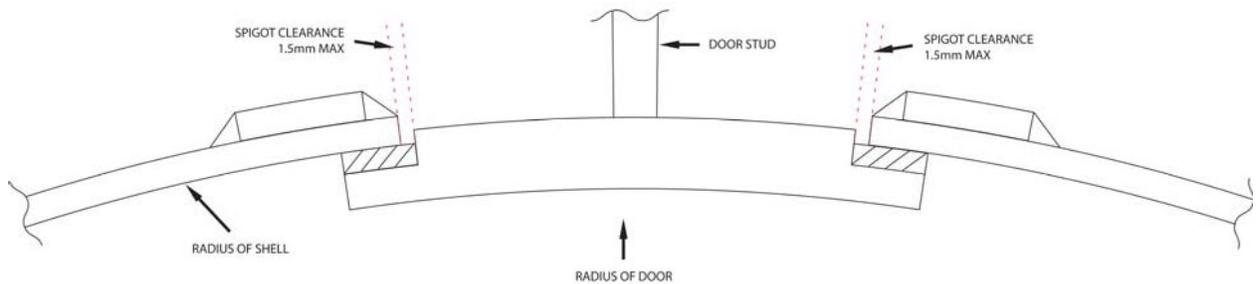
## Contour door - Can be fabricated/McNeill or pressed steel type

These doors will exhibit the same characteristics as a pressed door but in addition can have problems with trapping the joint and poor door assembly preventing a correct seal.

**Note:** The depth of the spigot should be such that the spigot enters the opening before the joint is compressed.
