## Pressure Systems

Guidelines for the competent person – In-service examination of manhole and handhole spigot gaps in boilers and other pressure vessels

**REFERENCE: PSG 14**  
**ISSUE: 01.1**  
**DATE: 07/01/2019**

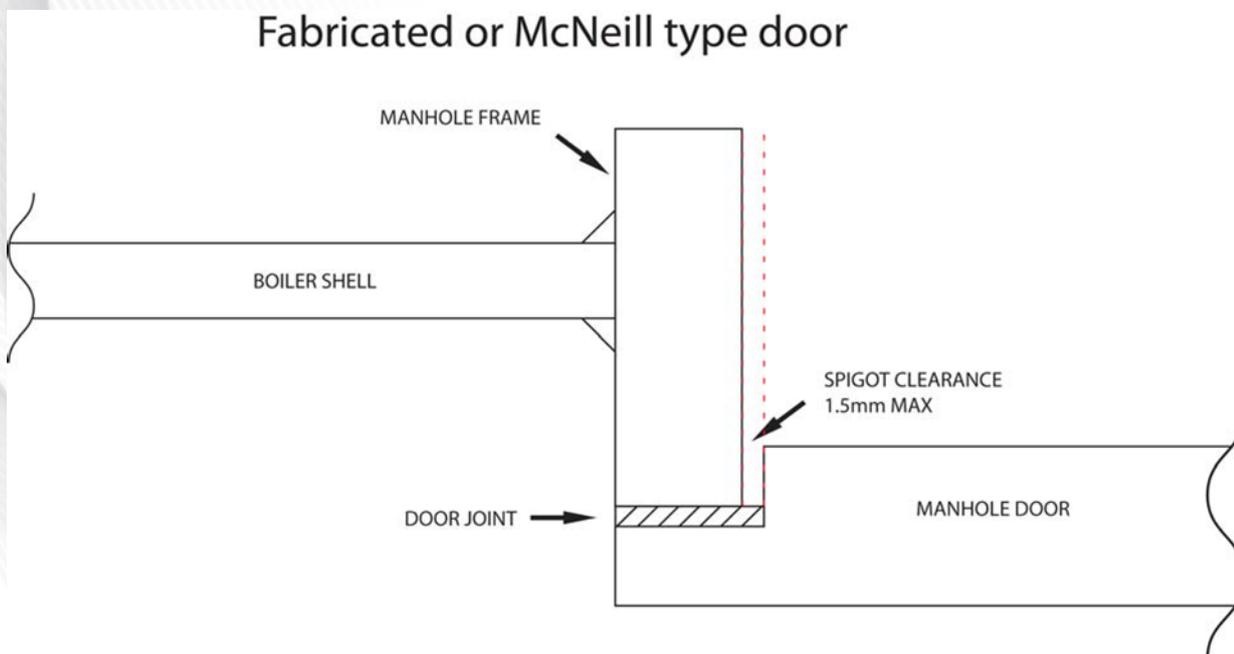
Spigot gaps can be readily measured with the door in position and with or without the door joint.

There are well established methods for the repair of fabricated or McNeill doors where the door spigot gap has increased. This method utilises weld overlay to the door, frame or plate edge dependant on where degradation has taken place and subsequent machining of the joint face.

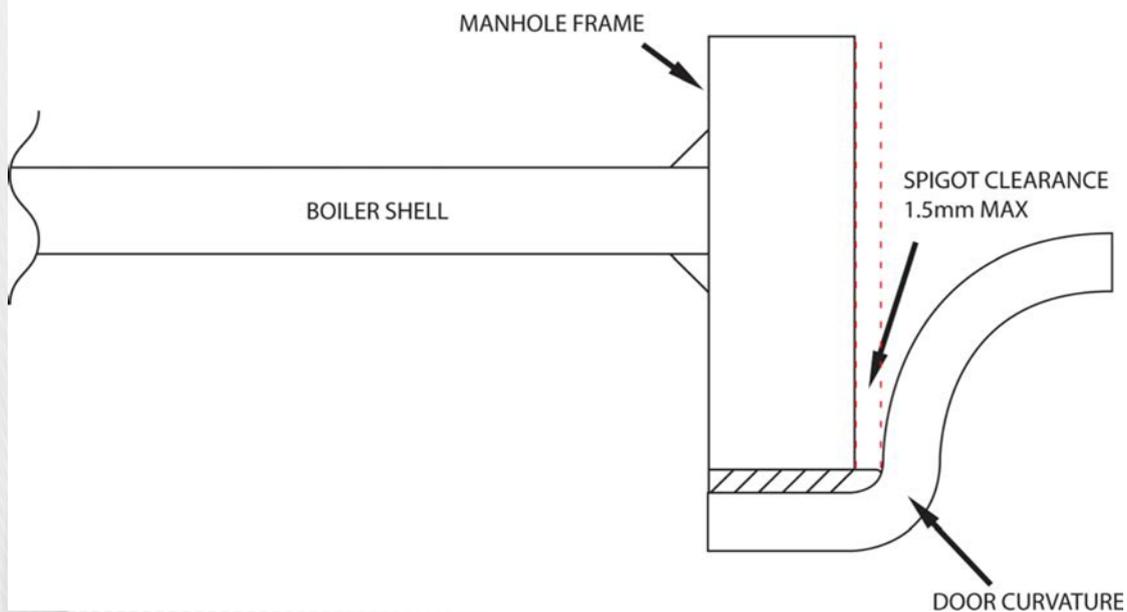
### Pressed steel type door

The curvature of the door and the radius adjacent to the joint seating area can interfere with the measurement depending on the thickness of the joint. Also the radius and the included angle can make the joint more susceptible to failure.

Generally welding should not be carried out on pressed doors as the heat applied may cause the door face to distort causing sealing issues.

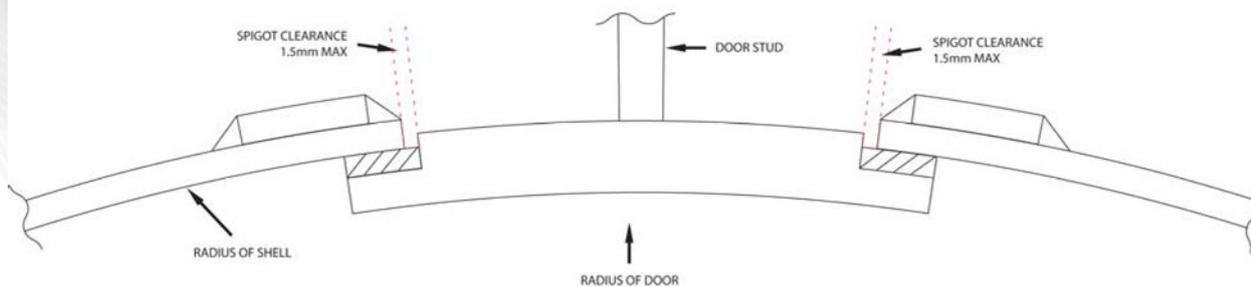
### Contour door - Can be fabricated/McNeill or pressed steel type

**Note:** The depth of the spigot should be such that the spigot enters the opening before the joint is compressed.
