SAFETY ASSESSMENT
FEDERATION

In-Service Inspection Procedures

Inspection of Wellman Robey
Ygnette/Sygnette Boilers (2007 – 2016)

REFERENCE: PEC 20
ISSUE: 01.1
DATE: 08/04/2021

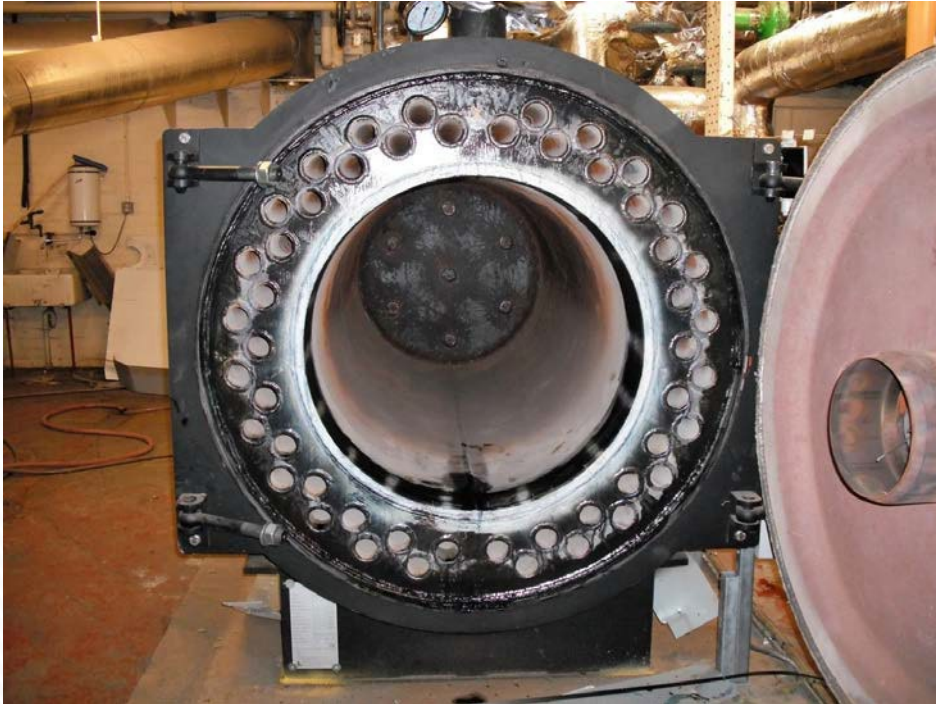
Note: Due to the door support ring (see Figure 4), the access for examination utilising compression wave scans from the front shell is restricted. If defects are found in any of the examined welds listed above it, will be necessary for removal of the door support ring to allow 100% compression wave scan.
