SAFETY ASSESSMENT
FEDERATION

In-Service Inspection Procedures

NDT of Rivet Heads

REFERENCE: NDTC 04

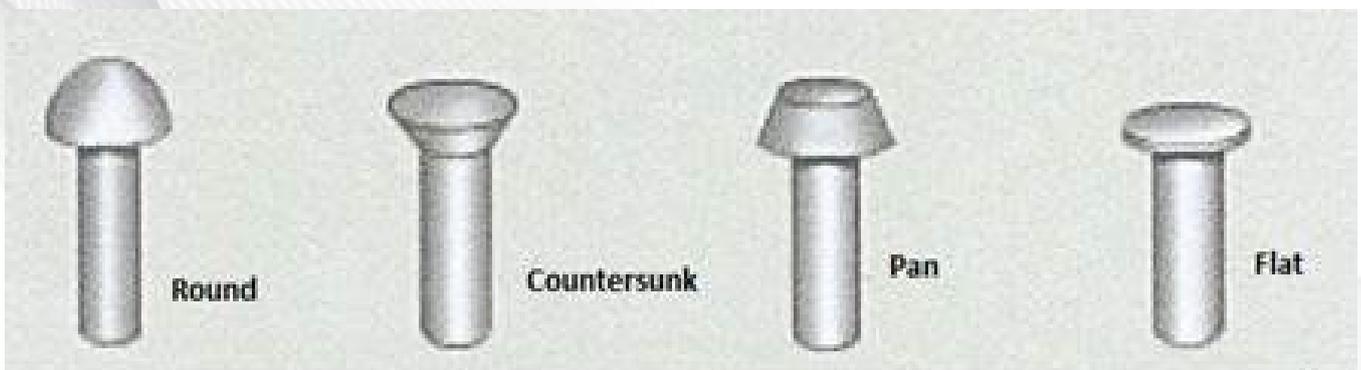
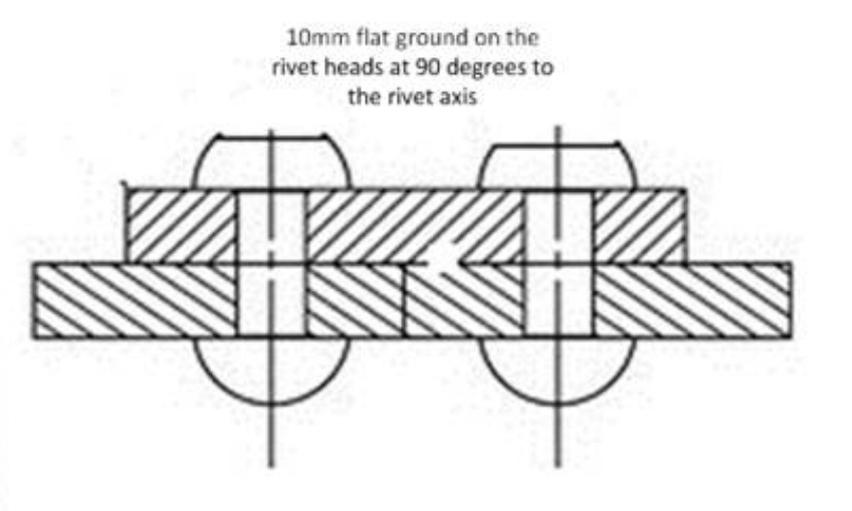
To achieve the above the criteria for probe seating is normally that on rounded or pointed rivet heads the NDT practitioner may require a small flat of approximately 10mm (5 pence piece) to be ground on the head in advance of the inspection visit ensuring that this is at 90° to the rivet axis. (See the diagrams below)

- On each rivet flattened the outer sharp edge can be removed by flapper disc, for cosmetic purposes, giving almost the same appearance as the adjacent rivets.

- When investigating for defects such as shear and partial shear (both by defect signal and loss of backwall echo), necking, and noting various rivet dimensions as per our procedure, we found this method to be the most accurate and repeatable test.

- Full probe contact can be achieved.
- Errors due to mode conversions, spurious indications and geometric issues can normally be discounted.
- The acceptance and rejection criteria of the inspection are to be agreed between the Competent Person, the owner/user and the NDT practitioner prior to the inspection being carried out in line with the Competent Person's own criteria (e.g. evidence of cracking and/or significant reduction of the total volume of the rivet head may be cause for rejection).
